Manhole Inspection Summary

Manhole # S13OO1056MH

Location Address: **2801 ROSALIND AVE**

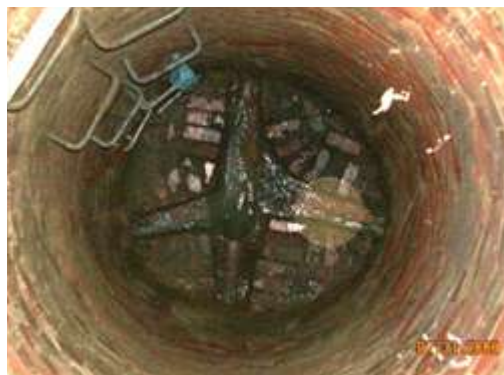
Top View

Barrel infiltration. Evidence of surcharge - Bench debris. Channel debris.

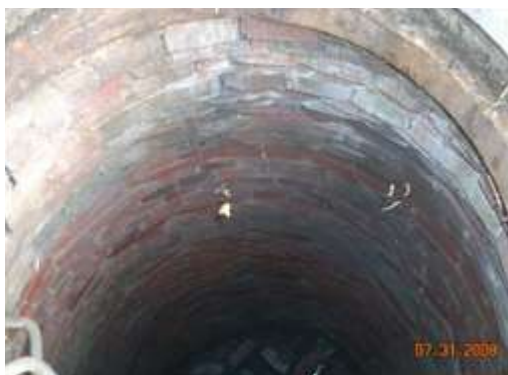
Defect

Adjustment, Corbel and Barrel infiltration - other side.

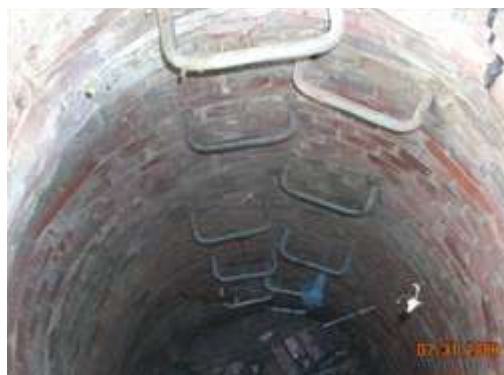
Defect

Adjustment, Corbel and Barrel infiltration.

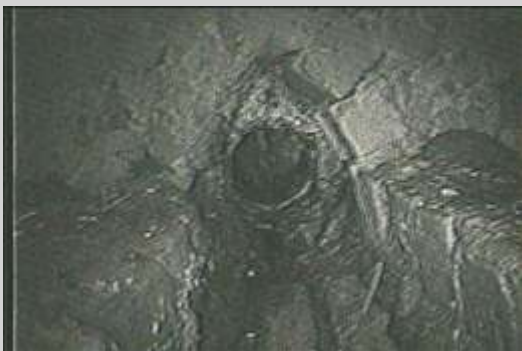
6 in. Circular Gravity Sewer Pipe In @ 4 O'Clock

Barrel deterioration and infiltration.

Infiltration: **Evidence** Pipe Seal Cond: **Broken**
